MEMORANDUM

To:	Gary Miller and Anne Foster U.S. Environmental Protection Agency	Date:	November 18, 2015
From:	John Laplante, John Verduin, Wendell Mears, and David Keith, Anchor QEA	Project:	090557-01.06
Cc:	Phil Slowiak, IP David Moreira, MIMC		
Re:	Post-TCRA Semi-Annual Inspection Report – October 2015

This document reports the results of the October 2015 inspection of the armored cap cover, fencing, and signage installed for the Time Critical Removal Action (TCRA) at the San Jacinto River Waste Pits Superfund Site (TCRA Site).

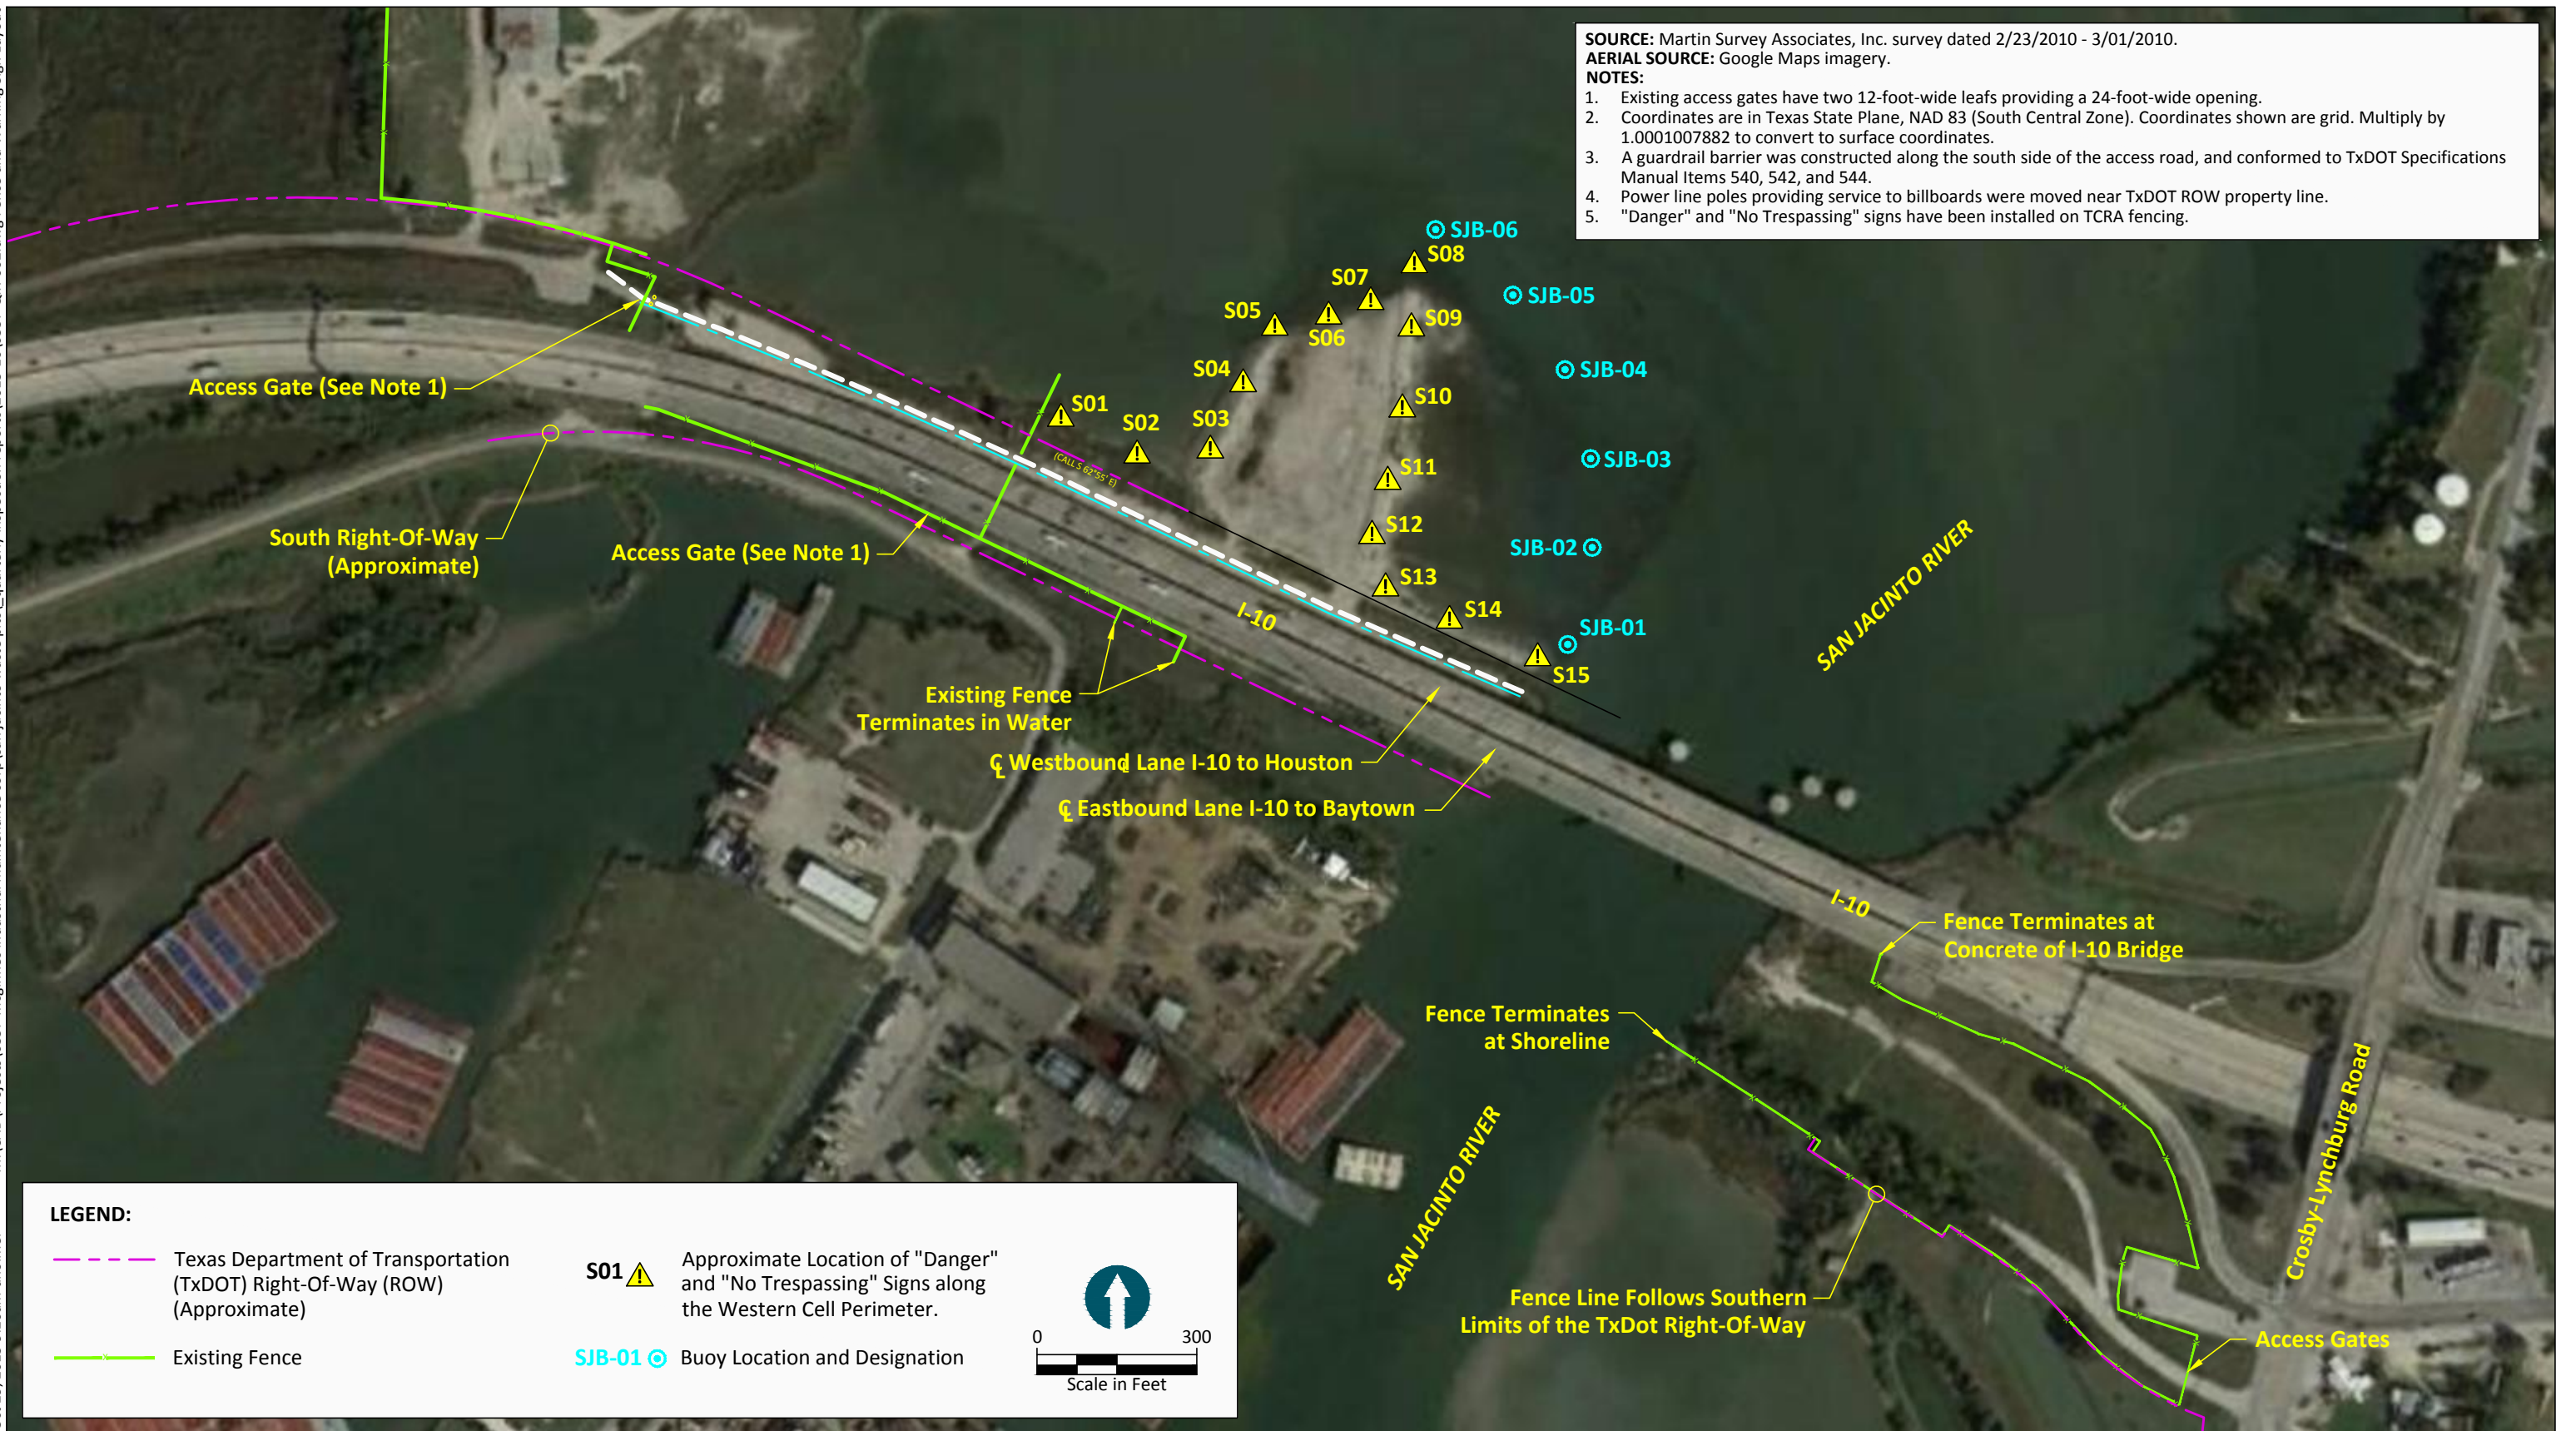
The perimeter fencing on the west and east banks of the San Jacinto River was visually inspected for breaches or other signs of damage. No breaches or other signs of fence damage were observed during the inspection for any of the three sections of the fence: the east bank, the west bank on the north side of I-10, or the west bank on the south side of I-10. For examples, see Photographs 12 and 14 through 16 in Appendix A.

"Danger" and "No Trespassing" signs are posted at regular intervals on the perimeter fencing surrounding the TCRA Site. For examples, see Photographs 12 and 14 in Appendix A. These signs were observed to be in place during the October 13, 2015 inspection.

3) at the end of the TxDOT right-of-way north of I-10 near the San Jacinto River. For examples, see Photographs 1, 4, and 15 in Appendix A. These three signs were observed to be in place and undamaged.
